Re: Renaissance Condominiums – Seattle, WA

INVESTIGATION FINDINGS FROM:

**Renaissance**

810 Taylor Avenue North Seattle, WA

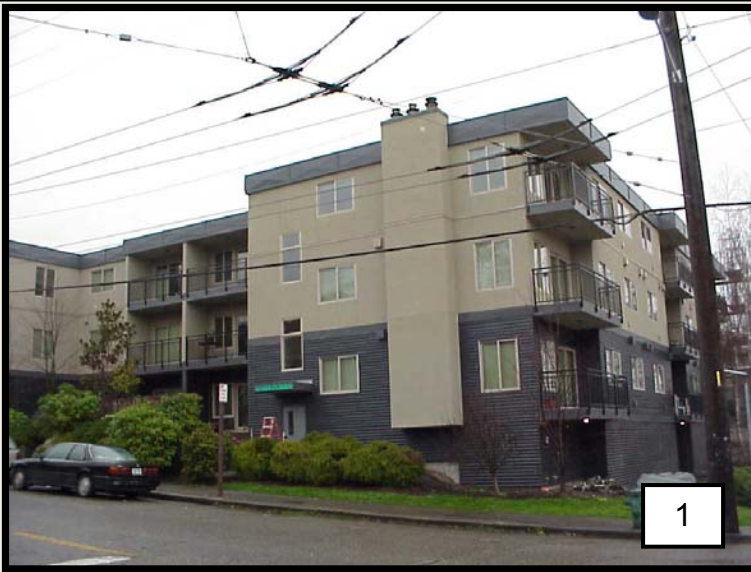
Tatley-Grund was contracted to perform a strip and re-clad of the Renaissance Condominium Building in 2005. A wet flash system sponsored by BEI was used on the windows installations.

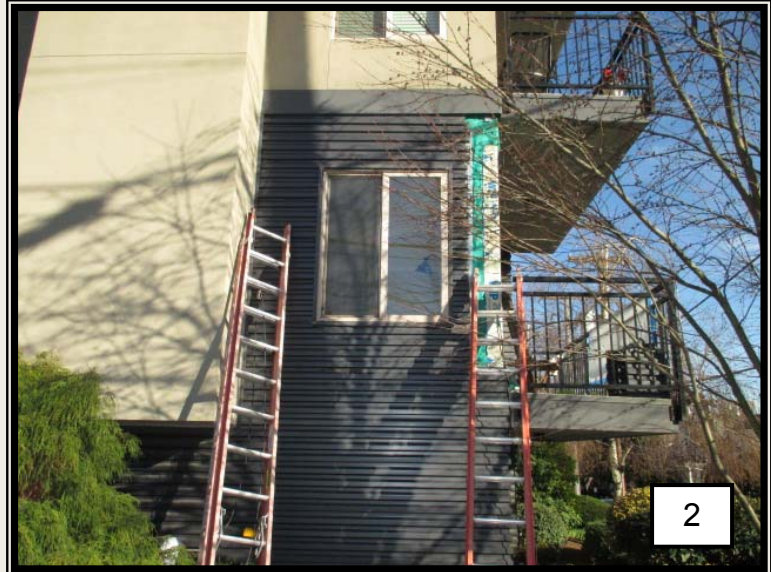
An inspection of the BEI Wet-Flash System after ten years of service was conducted by Tatley-Grund on February 17, 2015.

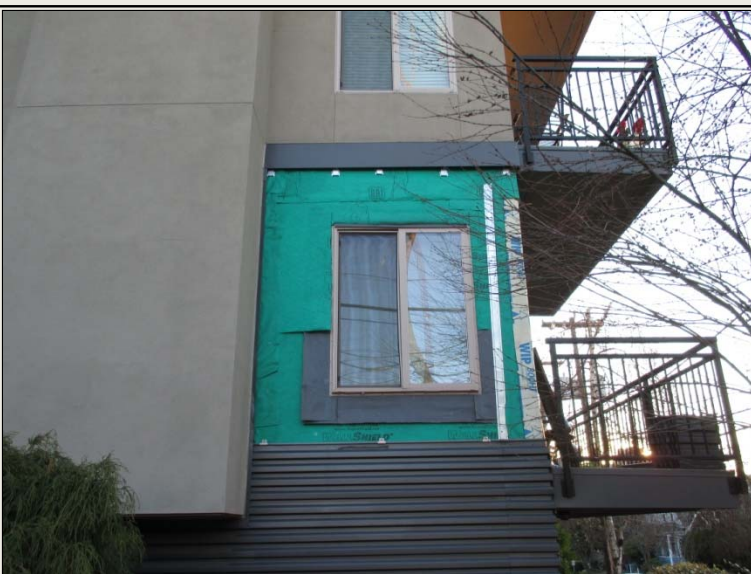
The surrounding metal cladding was removed to expose the window. The BEI Wet-Flash System was also inspected at the five year mark, and found to be performing as intended.

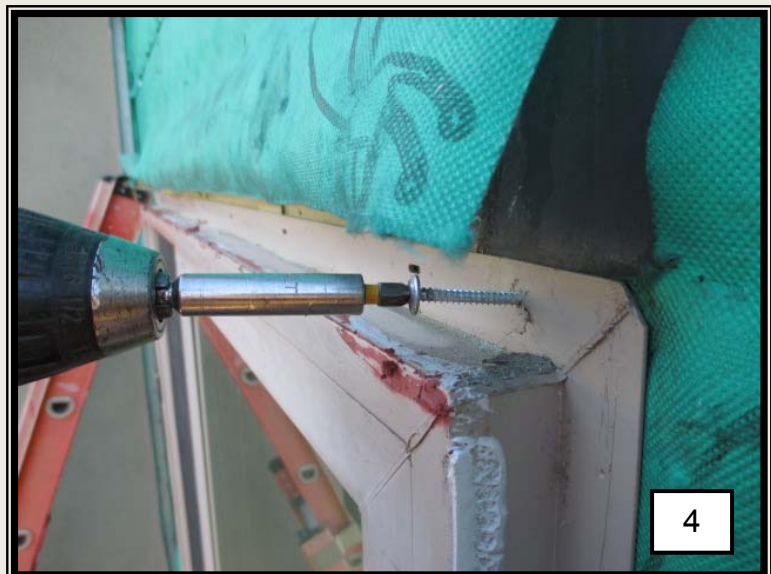
Mechanical fasteners that secure the window were found to be corrosion free upon removal. The Vapro-Shield Weather Resistant Barrier was observed in good condition.

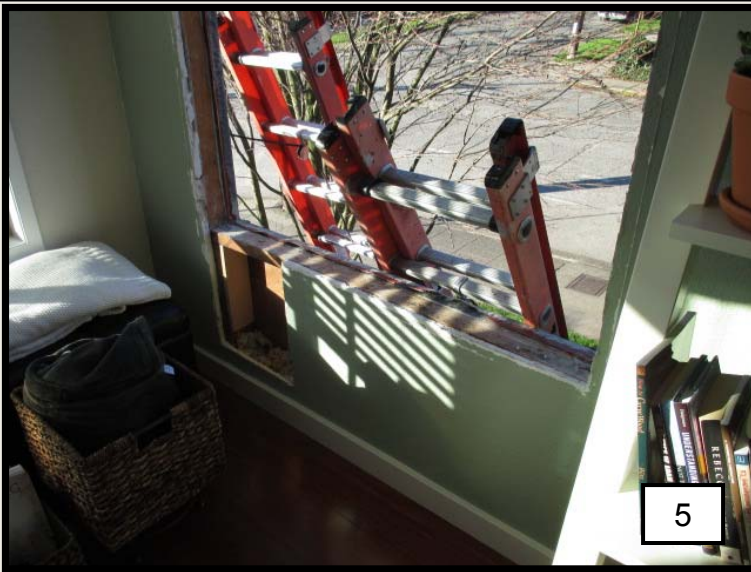
5

A cutout in the wallboard was made to observe the conditions in the wall cavity below the windows rough opening.

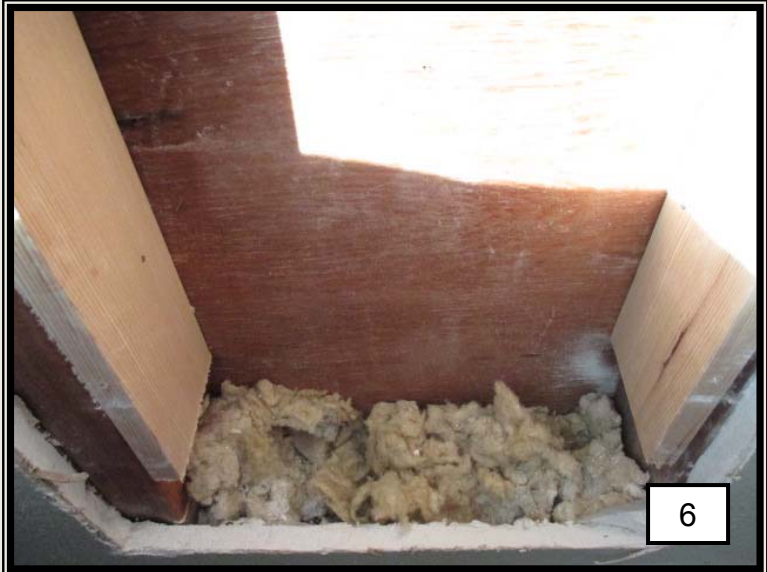
6

No staining was observed on the inboard side of the sheathing or the framing members and the insulation was noted clean and dry.

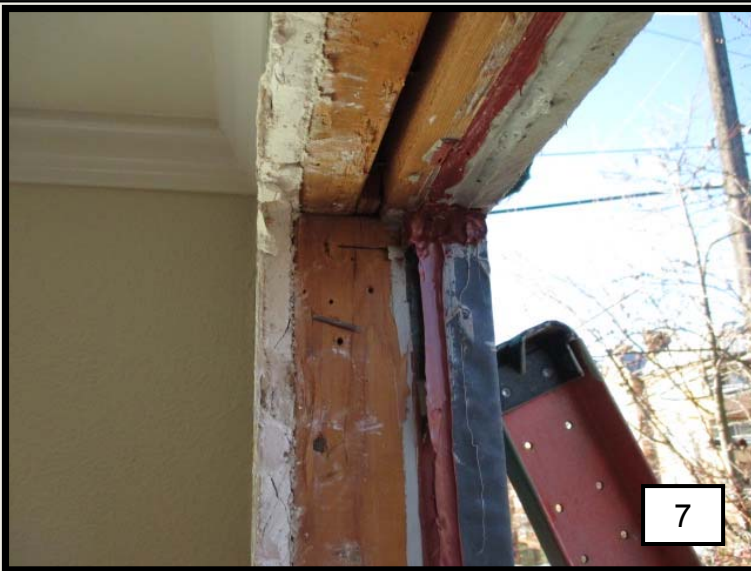
7

The BEI Wet-Flash is maintaining excellent adhesion to the wood substrate at the head and jambs of the rough opening.

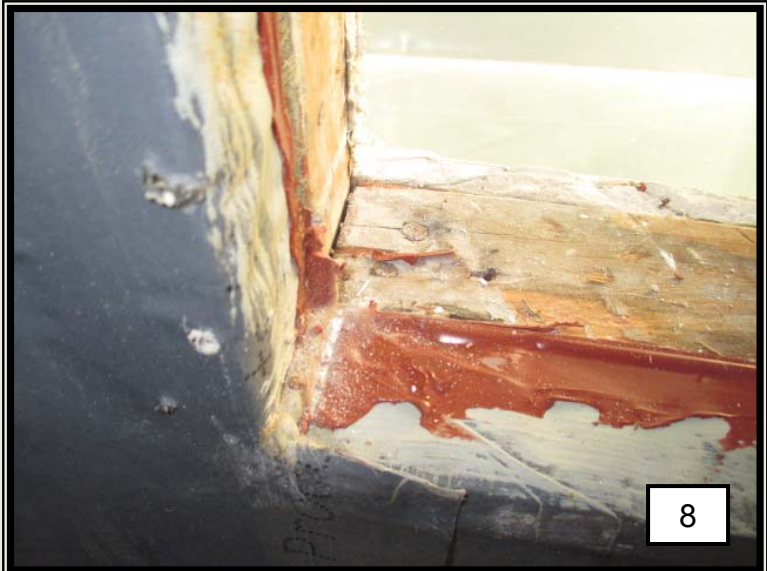
8

The Sure-Flash at the sill of the window is fully embedded into the Wet-Flash liquid applied membrane. No signs of water intrusion were visible at the framing of the rough opening.

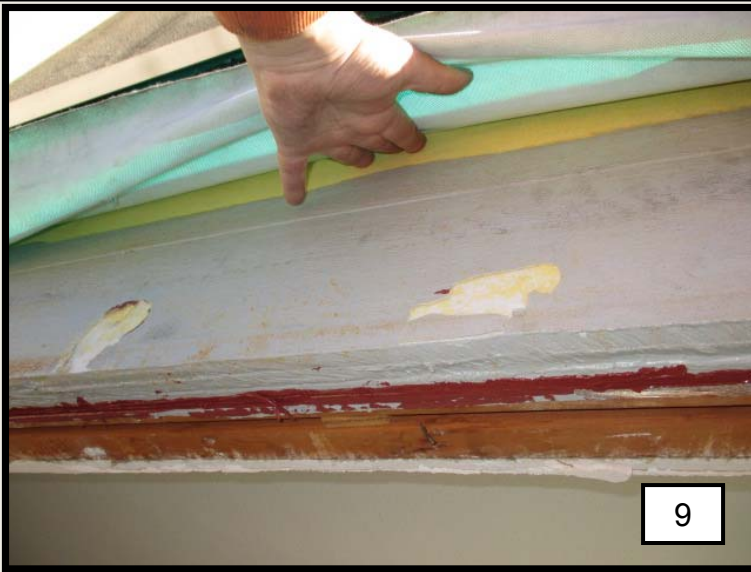
The Wet-Flash membrane is applied 9 inches above, and two inches into the rough opening of the Dens-Glass sheathing. No staining was observed on the exterior sheathing above the window opening.

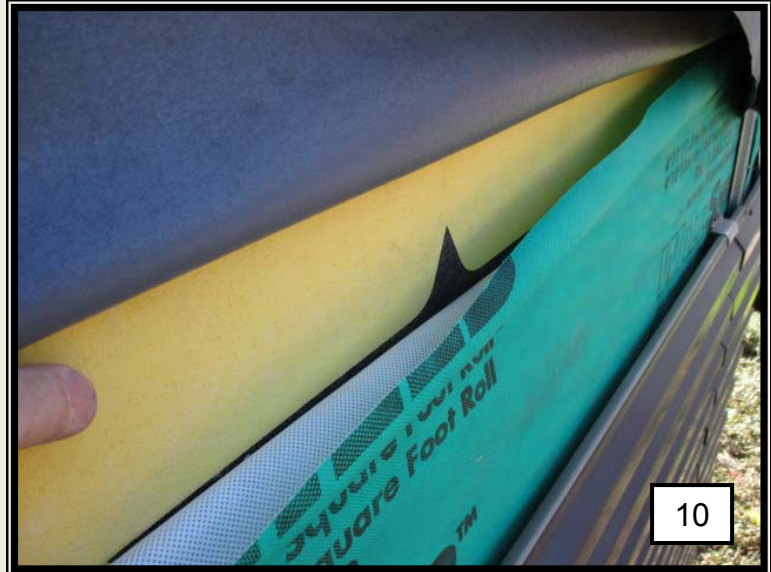
10

The Dens-glass exterior sheathing below the Sure-flash at the sill of the opening was noted to be in as new condition. No deterioration or staining was observed on the face of the Dens-Glass.

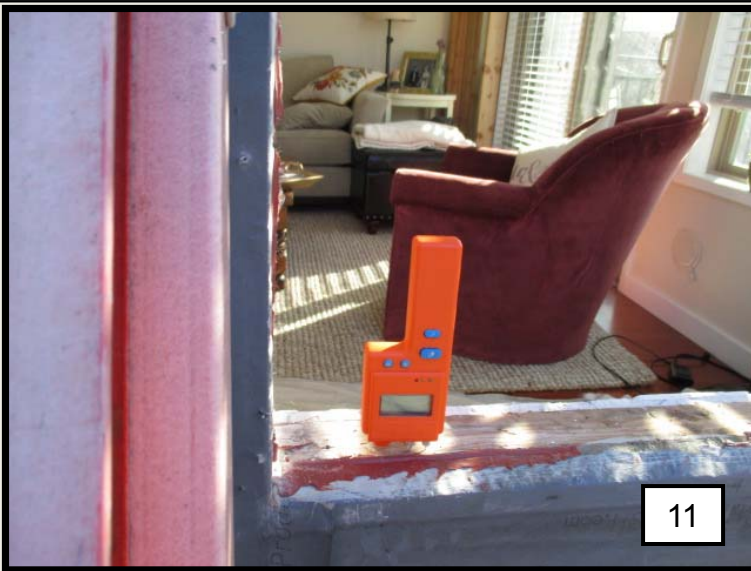
11

Moisture Meter Readings (MMR's) were gathered from the framing members after the windows removal. All readings were recorded in the normal range.

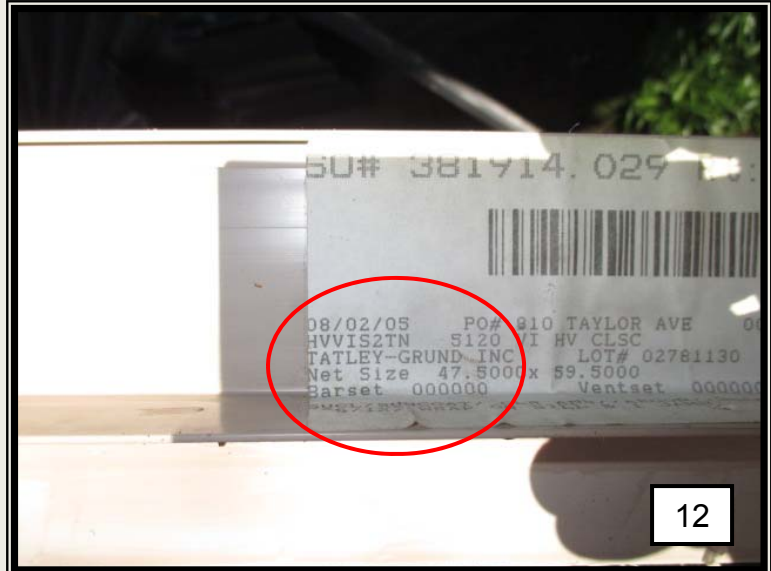
12

The tag on the jamb of the Milgard window is still legible, showing the born on date, of August 2nd, 2005. All components of the installation are performing as designed.
